RK8-E Handouts

digital	FIELD SERVICE TECHNICAL MANUAL				Option or Designator
	12 Bit <input checked="" type="checkbox"/>	16 Bit <input checked="" type="checkbox"/>	18 Bit <input type="checkbox"/>	36 Bit <input type="checkbox"/>	RKØ5

Title +5 VOLT REGULATOR 5409503				Tech Tip Number RKØ5-TT-1	
All	Processor Applicability			Author J. WALSH/A. MUIR	Rev Ø
	8	11		Approval HAROLD LONG	Date 9/12/72
					Cross Reference

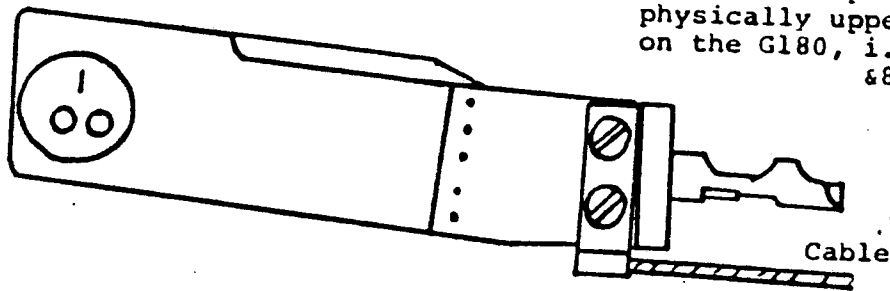
LOWER HEAD
30-10863-01

(Cable will plug into the physically upper set of pins on the G180, i.e. pins 5,6,7 & 8)

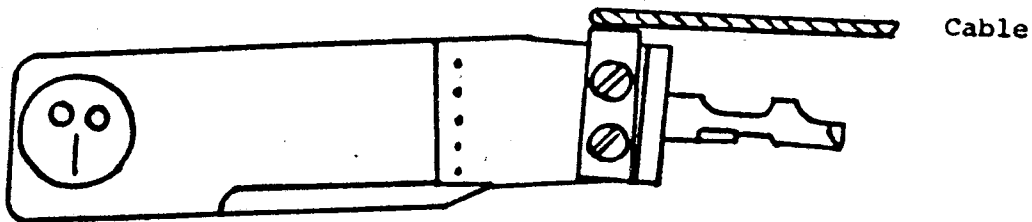
UPPER HEAD
30-10863-02

(Cable plugs to pins 1,2,3 & 4 on the G180)

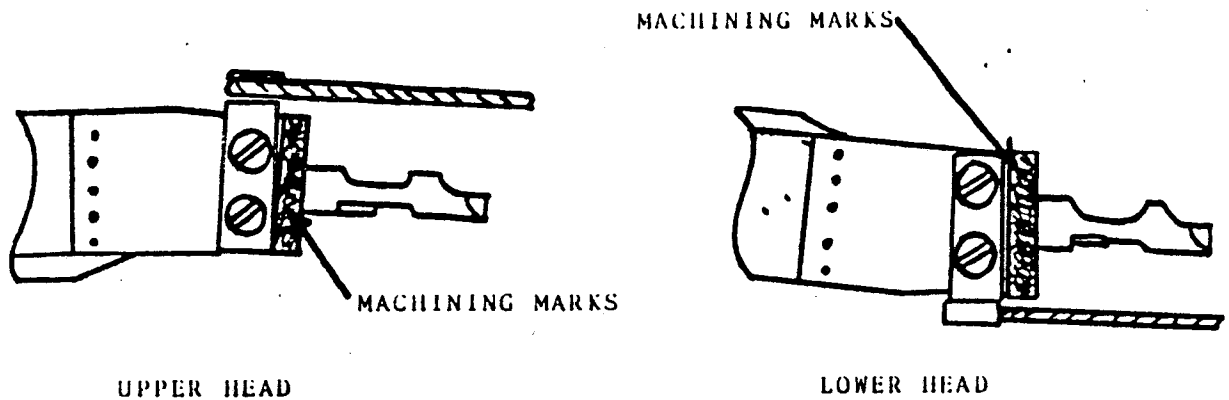
An ECO to the carriage assembly and one to the tailpiece of the R/W heads involved the machining of the flat surface where the head rests on the tang of the carriage. The new REV head will fit in the old REV carriage assemblies. Caution should be exercised however to insure that the pad of the head is on a plane which is parallel to that of the disk surface.

Heads on old REV tailpieces will not fit into new REV carriage assemblies.

New REV tailpieces can be identified by the machining marks on the shoulder. See Figure 1.

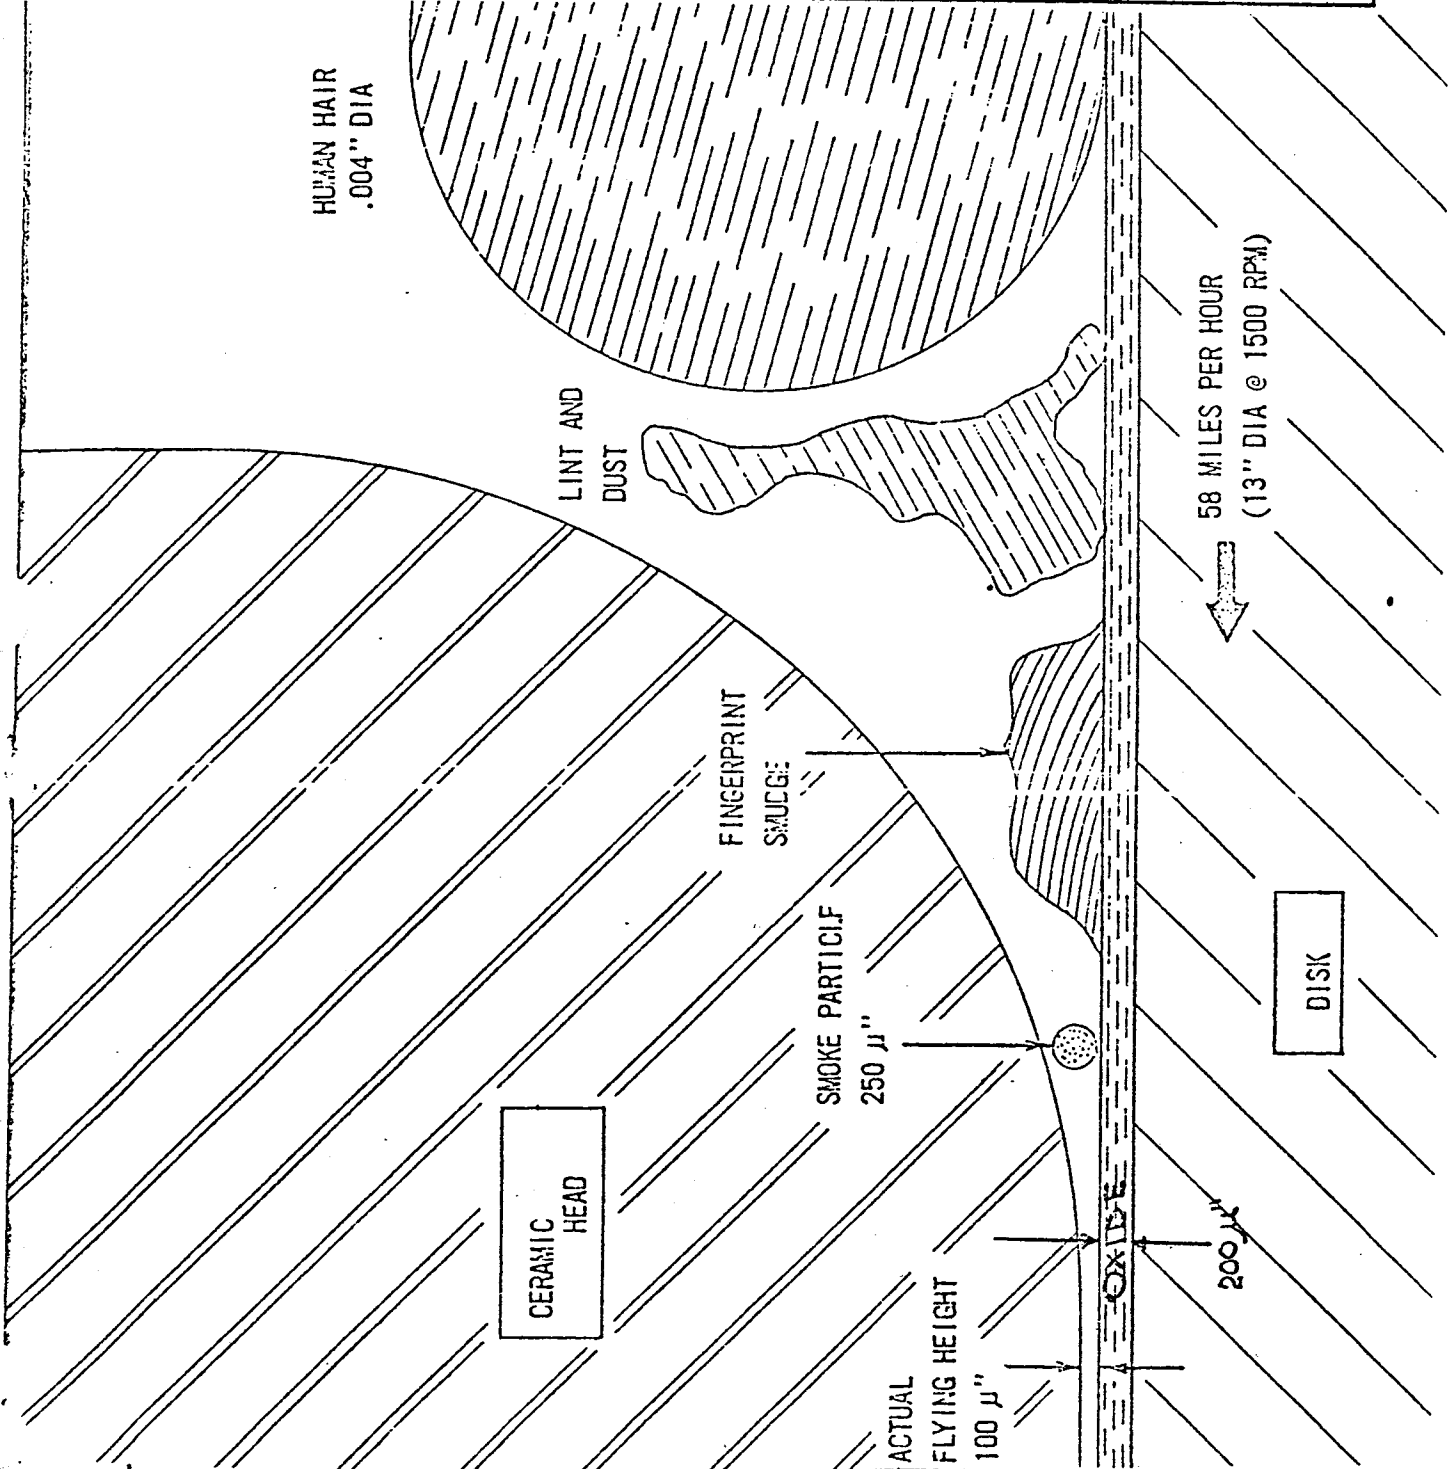
See attached picture. Yes, the head in an RK05 (or similar) disk drive actually "flies" closer than a finger print smudge or large smoke particle -- let alone a spec of dust, flake of dandruff or a hair. This may give you some idea why, when you can write your name in the dust on the outside of the disk cartridge, you may get disk oxide building up on the white ceramic head. Oxide build-up on the heads causes improper head flight and ERRORS if your're lucky-- CATASTROPHIC DESTRUCTION OF HEADS AND DISK if you're not. Keep the disk cartridge door shut and the disk in a clean bag or clean environment when not in the drive. And that's only dirt. There are other ways you can wreck a cartridge and/or drive; such as:

The small foil gimble spring which holds the white ceramic head to its support bracket is "tweaked" by the head manufacturer to ± 1 degree so that the head will "land" properly on the boundary layer of air which spins along with the disk. Now, if you BEND the head in any way, you mess up this landing angle. When the head does not land right, usually one edge of the head "bites" through the air boundary layer and dings the oxide. Usually, the head will bounce and fly. Occasionally, however, known to us all, the head doesn't get up and fly -- it digs and burrows into the oxide, which happens to be moving at about 58 miles per hour.

SO: Disks, like jokes in the presence of ladies, should be kept clean.
 Do not bend heads!
 Do not rape the drive with the cartridge.
 Do not mix bad disks.

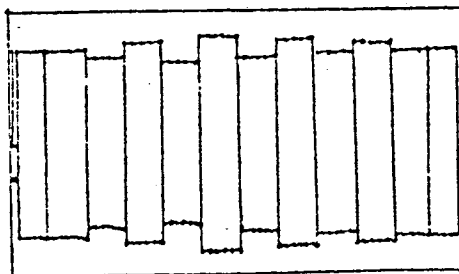
Figure 2
Considerable runout. NOTE: If this condition exists ensure that mating of spindle and disk are clean. Improper mating can cause such runout.

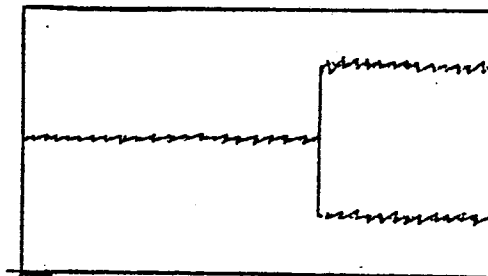
Figure 3

a. Error = -100%

Large misalignment. Head close to CYL 104. (Further misalignment only reduces signal on right of screen).

11. If one of the illustrated waveforms is present, note the direction in which the head must be moved to obtain the "right on" indication. If the head must be moved backward, loosen the head clamp and adjustment screws and gently push the head all the way back into the carriage. If the head must be moved forward, loosen only the clamp screw, then turn the adjustment screw until the correct waveform is obtained. (The adjustment screw is a vernier which only moves the head forward and should not be left torqued down after this adjustment).

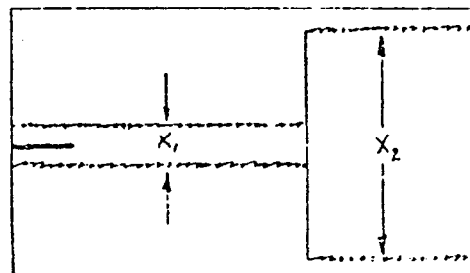
b. Error = -72%

Head considerably misaligned. Smaller left amplitude indicates head position less than CYL 105.

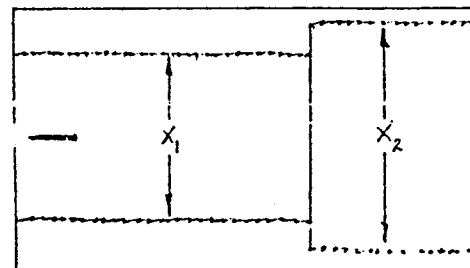
Figure 5

c. Error = -15%

Head slightly misaligned. Smaller left amplitude indicates head position less than CYL 105.

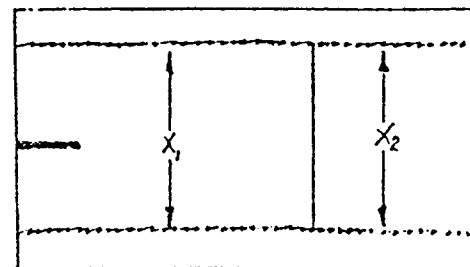
Figure 6

d. Right On

Head correctly aligned at CYL 105. Amplitudes are equal.

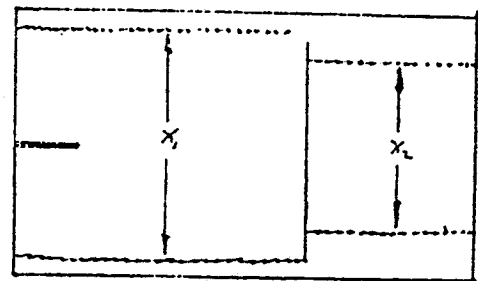
e. Error = +15%

Head slightly misaligned. Larger left amplitude indicates head position more than CYL 105.

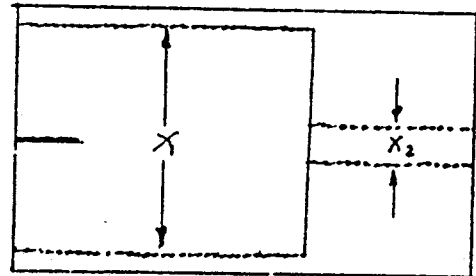
Figure 8

f. Error = +72%

Head considerably misaligned. Larger left amplitude indicates head position more than CYL 105.

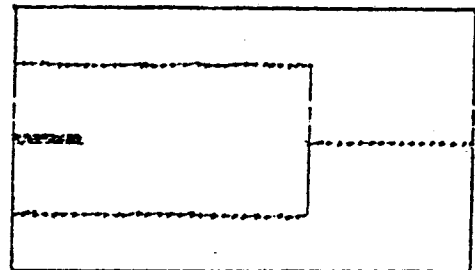
Figure 9

g. Error = +100%

Large misalignment. Head close to CYL 106. (Further misalignment only reduces amplitude of signal on left side of screen).
