RK8-E Handouts

digital	FIELD SERVICE TECHNICAL MANUAL				Option or Designator
	12 Bit <input checked="" type="checkbox"/>	16 Bit <input checked="" type="checkbox"/>	18 Bit <input type="checkbox"/>	36 Bit <input type="checkbox"/>	RKØ5

Title +5 VOLT REGULATOR 5409503				Tech Tip Number RKØ5-TT-1	
All	Processor Applicability			Author J. WALSH/A. MUIR	Rev Ø
	8	11		Approval HAROLD LONG	Date 9/12/72
					Cross Reference

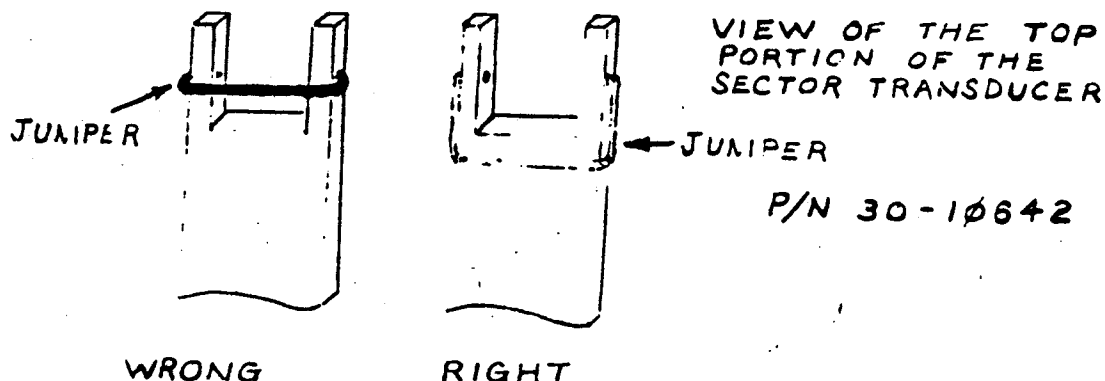
A number of improperly wired sector transducers were produced some time ago. We feel that our logistics system has been purged of these defective parts, however, as a precautionary measure, this tech tip is being issued. Below, both types of transducers are illustrated. Should replacement become necessary, it is suggested that a visual inspection be made. Improperly wired transducers should be disposed of and replacement ordered from Maynard or respective regional stockrooms.

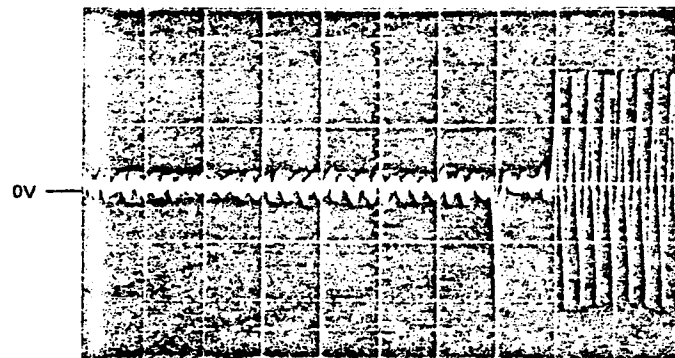
Figure 4 Index/Sector Waveform

13. If R6 does not adjust the average of the two pulses to 70 usec, perform the following:
- Loosen the sector transducer screws.
 - If the average of the pulses is greater than 70 usec, move the transducer towards the airduct, if less than 70 usec move transducer away from the airduct.
 - Tighten the screws and perform steps 11 and 12.
14. If the time between the two pulses is greater than 20 usec, one or possibly both of the heads must be replaced. DO NOT BEND THE HEADS. The head to be replaced can only be found by trial and error.
